**AVIATION TECHNOLOGY SERVICES:  
PIPELINE LEAK DETECTION**

Final Report for the Period of August to November, 2006  
Date Completed: January 2007

Prepared for the United States Department of Energy  
Office of Fossil Energy

Rocky Mountain Oilfield Testing Center (RMOTC)  
Work performed under CRADA 2006-075

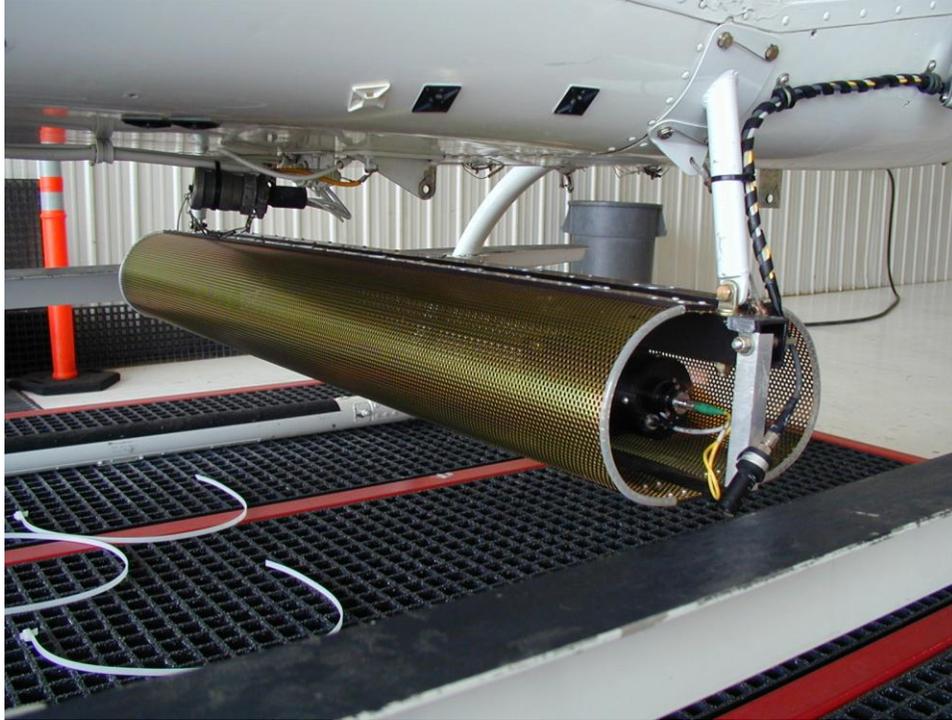
**Figure 3.** The Boreal laser sensor cell, without cover.

The ATS airborne leak detection service is based around the Boreal laser. The Boreal laser is a robust methane detection system, tuned to the absorption wave-length of the methane molecule and firing inside a porous, self-contained sensor cell attached near the bottom of the helicopter, Figure 3. Air passing through the laser cell is sampled over 300 times per second, accurately monitoring methane levels as low as one part per million (1 ppm). Laser accuracy is maintained through a patented self-calibration system which references its own pure methane sample every 3 to 6 seconds; thus increasing accuracy and eliminating background level drift. The laser samples the atmosphere over a pipeline and identifies rising methane plumes associated with leaks. At 50 mph and approximately 50 feet above ground level, the pilot follows a preloaded pipeline route using latitude and longitude points on a Global Positioning Satellite (GPS) receiver. Advantages to the system are that temperature changes, ground, and cloud conditions do not affect the performance of the Boreal laser. Excellent survey results are achieved in wind speeds up to 18 mph. To complete the airborne pipeline leak detection system, ATS uses a state of the art GPS directed mapping program linked to a color digital video and audio capture program that plots methane levels collected and records them to a hard drive. Post-survey analysis and archiving of the pipeline data can be viewed on the mapping program to visually review exact locations of problems such as right of way issues, exposed pipe,

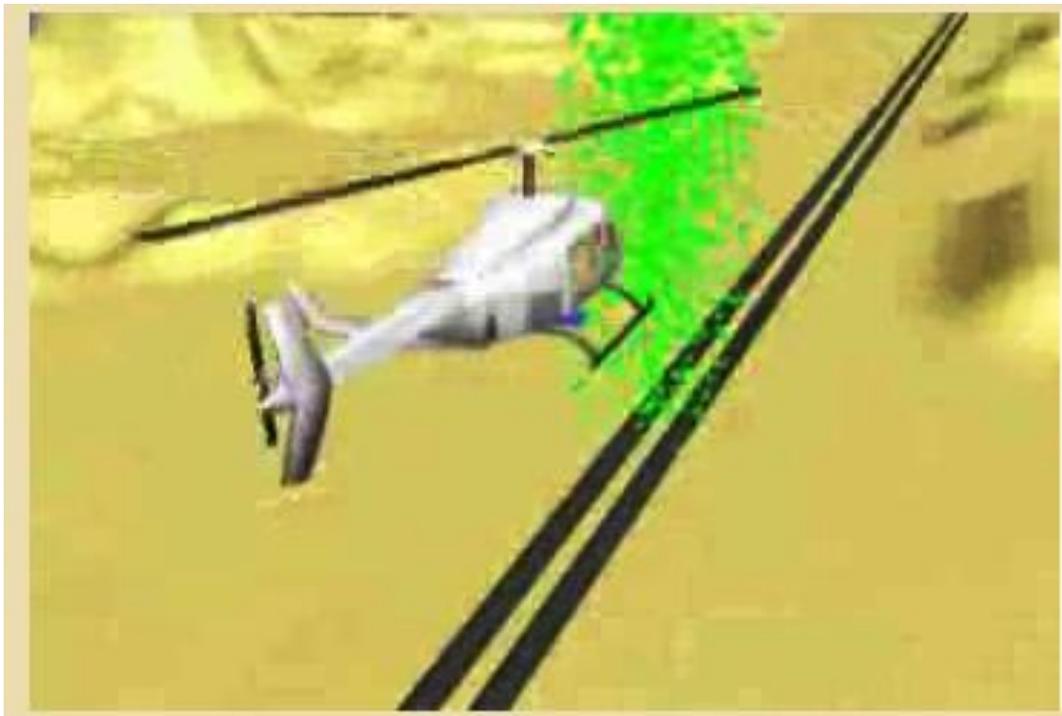
**Figure 4.** Simulation of ATS’s helicopter over a pipeline with the methane plume indicated in green.

ATS conducted a series of leak detection tests with its airborne laser methane detection system between September 12<sup>th</sup> and 14<sup>th</sup>, 2006. ATS flew their leak detection system over the pipeline each time the scenario was altered. To perform an impartial and controlled evaluation of ATS’s airborne laser leak detection system, ATS was required to provide an analysis of their testing results prior to RMOTC providing the actual leak data scenarios. ATS then reevaluated their results based on the actual data.
